## หนังสือรับรองความมั่นคงแข็งแรงของอาคาร

เรื่อง รับรองความมั่นคงแข็งแรงของอาคารหลังได้รับผลกระทบจากแผ่นดินไหว

อาคารหอพักนักศึกษา B QUEEN OF SHEEBA

## Certificate of Structural Integrity

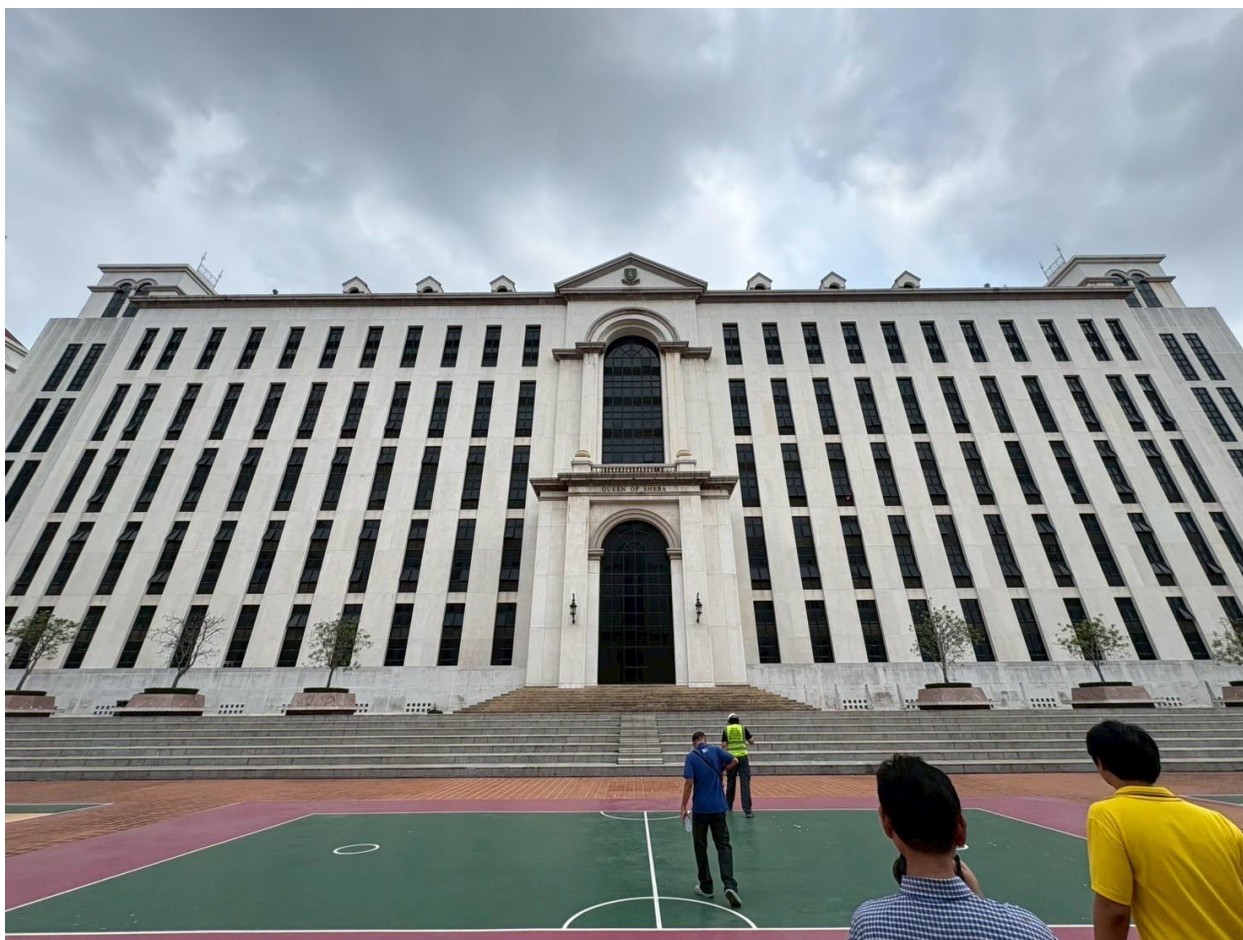
ภาพถ่ายอาคาร

ซึ่งได้รับผลกระทบจากแผ่นดินไหว โดยผลการพิจารณาตรวจสอบพบว่าโครงสร้างหลักของอาคารอยู่ในสภาพปกติ ไม่พบความเสียหาย ชำรุดบกพร่อง หรือสิ่งซึ่งบ่งบอกว่าอาคารเป็นอันตราย หรือไม่ปลอดภัยต่อการใช้งาน พบเพียงความเสียหายบางส่วนในส่วนงานสถาปัตยกรรม เช่น ผนัง ฝ้า วัสดุตกแต่ง ซึ่งไม่กระทบต่อโครงสร้าง แต่ควรทำการซ่อมแซมแก้ไขให้อยู่ในสภาพปกติพร้อมใช้งาน
